*APPENDIX H*  
*HAZARDOUS MATERIALS*  
*DOCUMENTATION*

**LIMITED ASBESTOS SURVEY REPORT**

**SAN ANTONIO INTERNATIONAL AIRPORT  
BUILDING 1039 - BREAK ROOM  
SAN ANTONIO, TEXAS**

**PROJECT NUMBER: 1908285ARG**

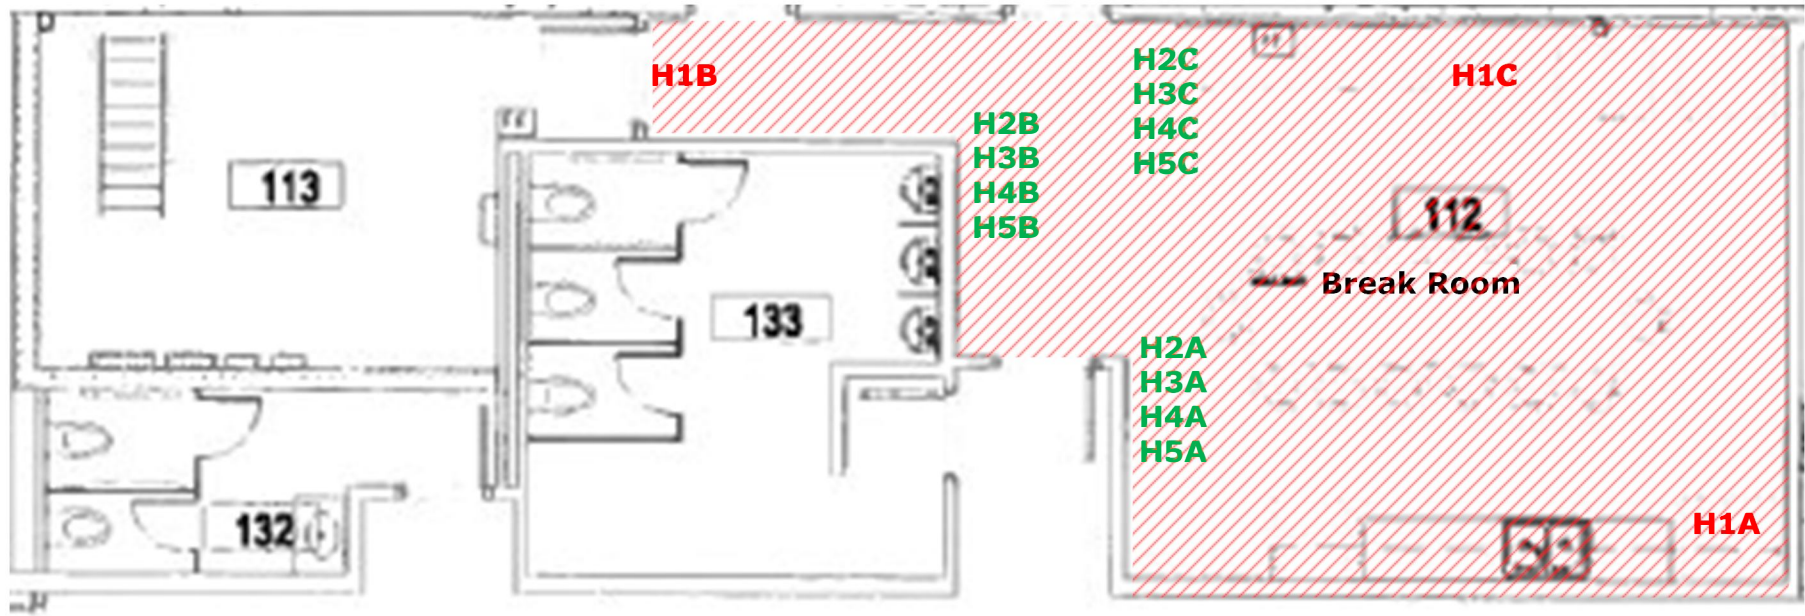
**Asbestos Survey Bulk Sample Diagram  
San Antonio International Airport  
Building 1039 - Break Room**

Regulated ACM was found in the following materials:

Homogeneous Area	Description/ Location	Sample ID	Percent (%) Asbestos	Quantity	Condition	Friable/ Non-friable
1	12x12 Cream w/ Tan Streak Floor Tile and Black Mastic	H1ABC	2% Chrysotile & 2% Chrysotile	~ 485 Square Feet	Good	Non-friable

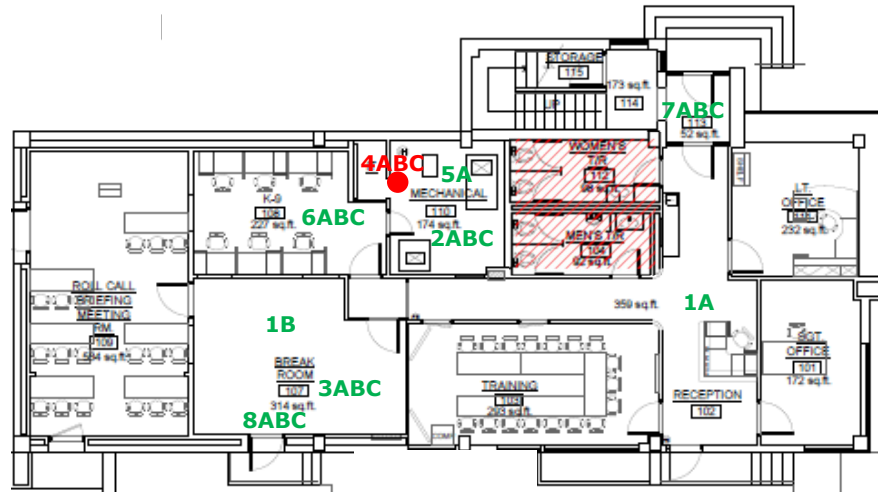
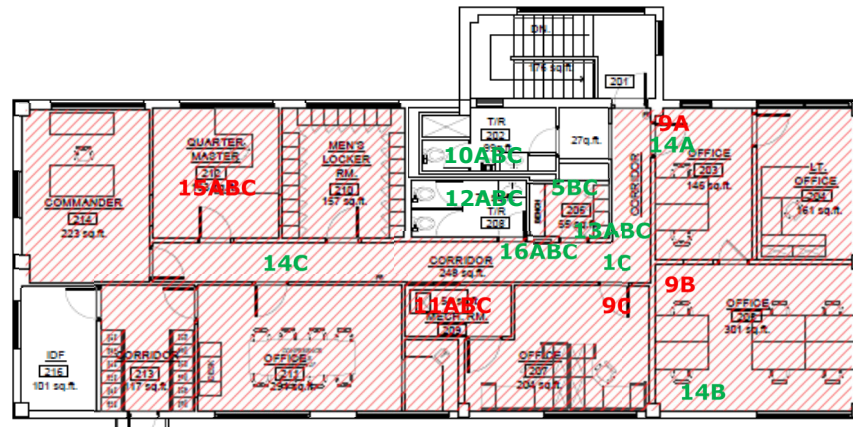
# Asbestos Bulk Sample Diagram San Antonio International Airport - Police Department Building

Greater than one percent (>1%) asbestos was found in the following materials:

<b>Homogeneous Area</b>	<b>Description /Location</b>	<b>Sample ID</b>	<b>Percent (%) Asbestos</b>	<b>Quantity</b>	<b>Condition</b>	<b>Friable/ Non-friable</b>
4	Exhaust flue / Mechanical Room	4B	10	18 linear feet	Good	Non-friable
9	Floor tile and mastic below carpet / Second floor	9A	10	~1,040 square feet	Good	Non-friable
11	9x9" floor tile / Second floor mechanical closet	9A	10	12 square feet	Good	Non-friable
15	Floor tile below wood floor / Office #210	15A	10	~120 square feet	Good	Non-friable

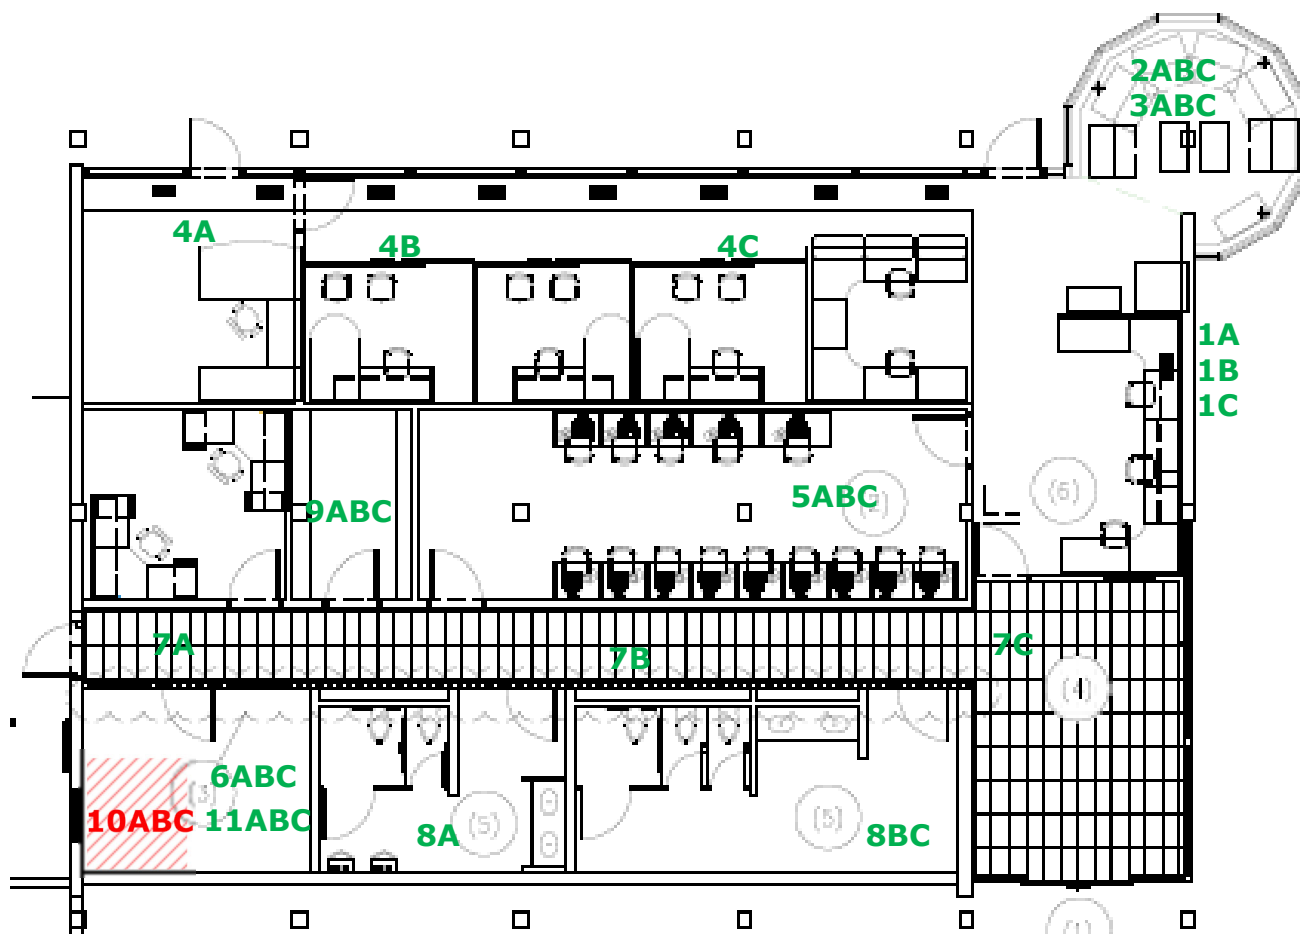
# Asbestos Bulk Sample Diagram San Antonio International Airport - Badge & ID Building

Greater than one percent (>1%) asbestos was found in the following material:

<b>Homogeneous Area</b>	<b>Description /Location</b>	<b>Sample ID</b>	<b>Percent (%) Asbestos</b>	<b>Quantity</b>	<b>Condition</b>	<b>Friable/ Non-friable</b>
11	HVAC duct, black sealant / Mechanical Room	11A	12	10 square feet	Good	Non-friable
