*APPENDIX H*  
*HAZARDOUS MATERIALS*  
*DOCUMENTATION*

**LIMITED ASBESTOS SURVEY REPORT**

**SAN ANTONIO INTERNATIONAL AIRPORT  
BUILDING 1039 - BREAK ROOM  
SAN ANTONIO, TEXAS**

**PROJECT NUMBER: 1908285ARG**

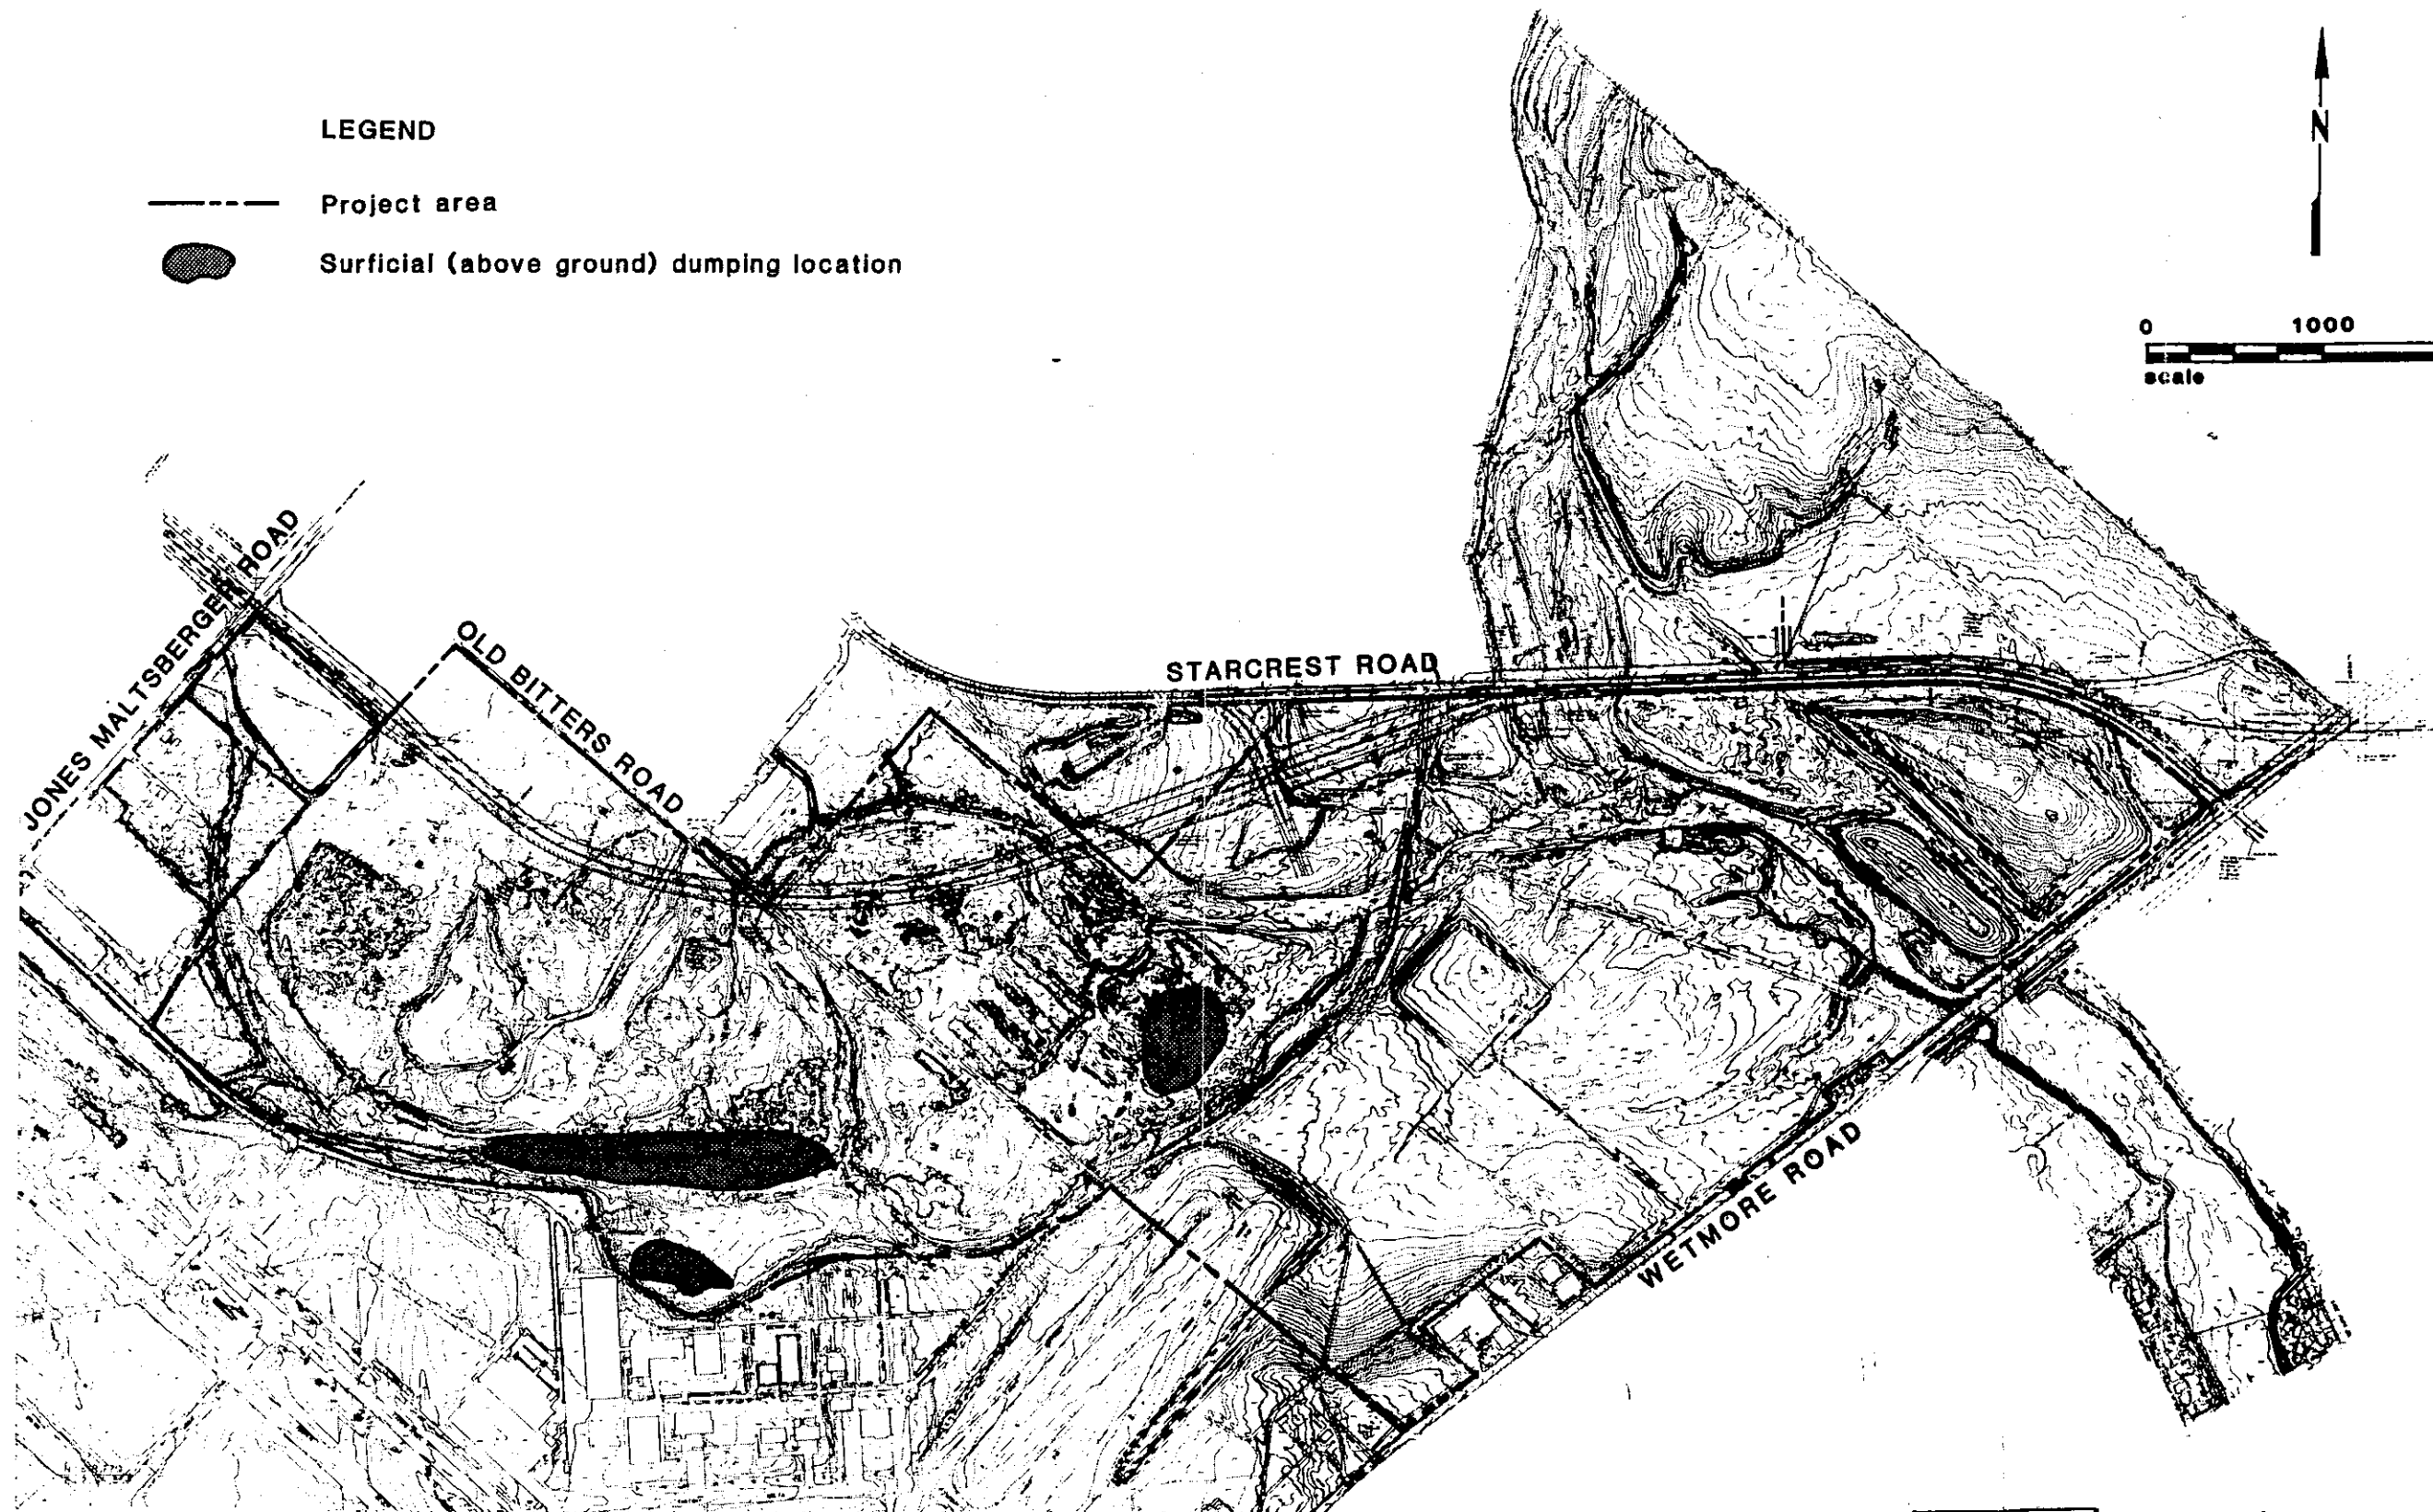
**SURFICIAL DUMPING LOCATION MAP**  
SAT LRMP - SAN ANTONIO, TEXAS

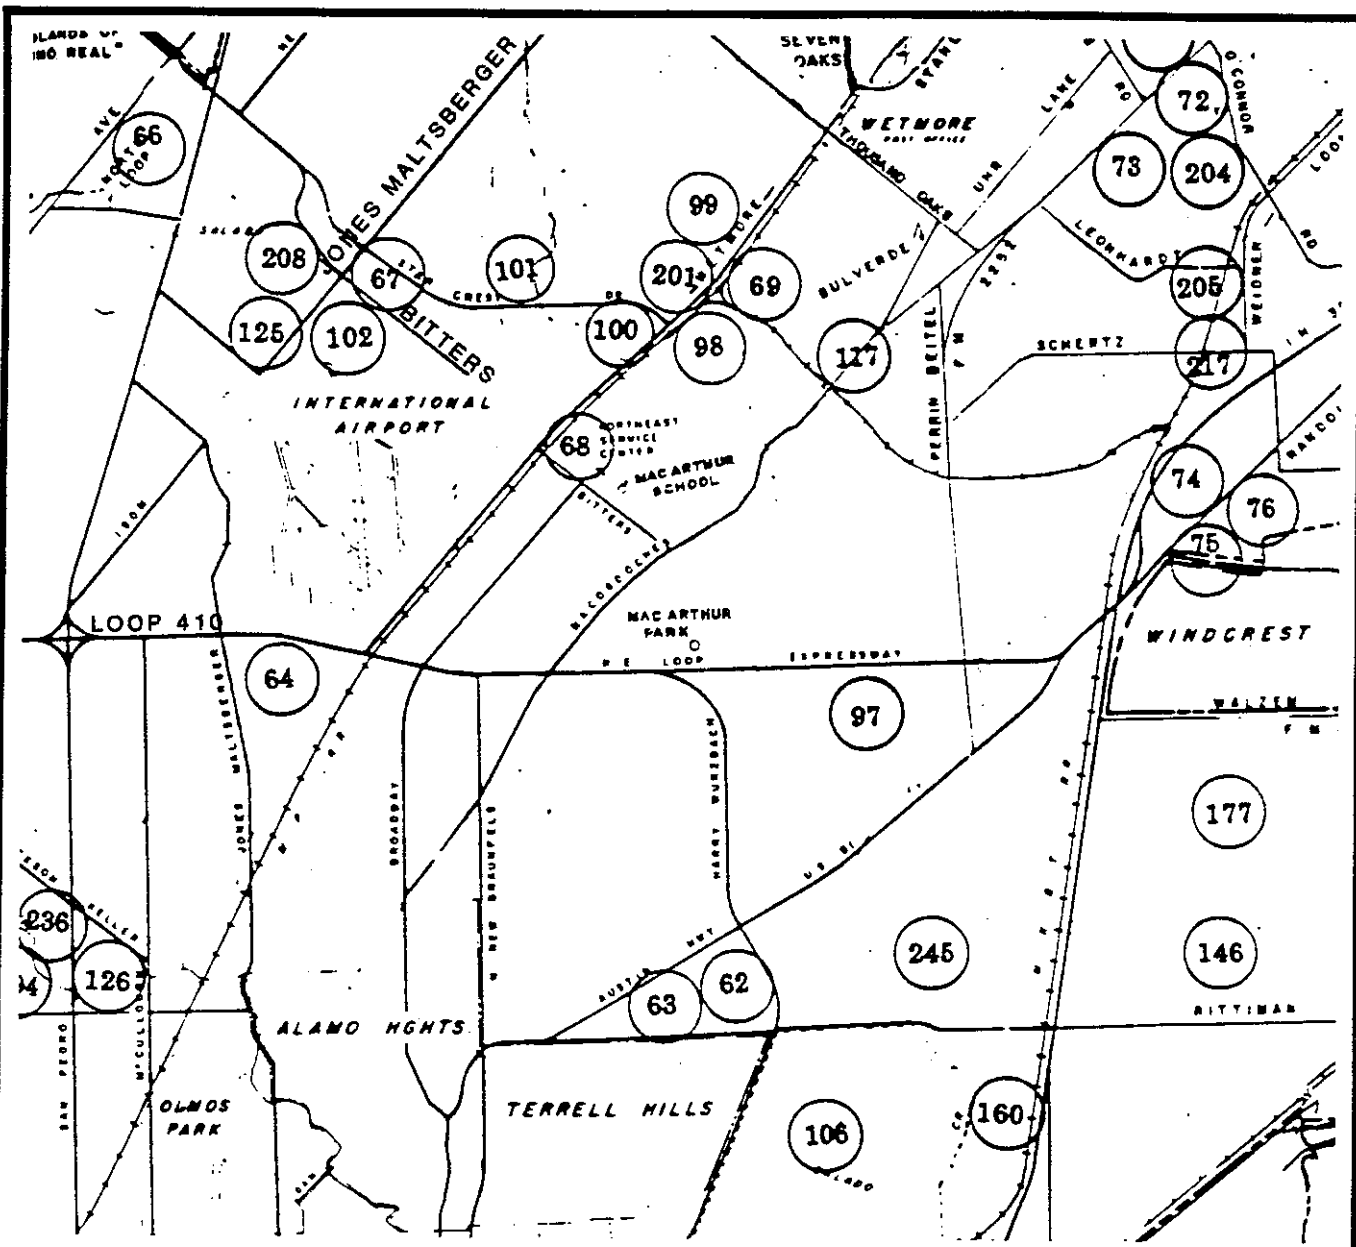
PLATE 5b

A portion of a map of landfill locations within Bexar County (CSA, 1989) is presented on Plate 5A and shows five sites within and immediately adjacent to the project area. The map numbers of these sites are 67, 100, 101, 102, and 201. The available information on these sites is shown on Plate 5B. There is a discrepancy between the locations shown on Plate 5A and the location descriptions shown on Plate 5B. It appears that the location descriptions shown on Plate 5B are more accurate.

According to Plate 5B, Site 100 is located on Wetmore Road north of Starcrest and thus does not directly affect the project area. The street addresses of Sites 67 and 102 indicate that they are located on the south side of Old Bitters Road near Salado Creek. There is no indication of landfilling in these areas, but some CDW is disposed in a pit just west of the Airport Fire Practice Area (Plate 2). This CDW appears to be of recent origin and no other landfilling is indicated by aerial photographs or surficial features.

Site 101 is the CSA Waste Transfer Station (Plate 2), which has a street address of 11601 Starcrest according to Plate 5B. Municipal waste is transferred at this location, but none is disposed or stored.

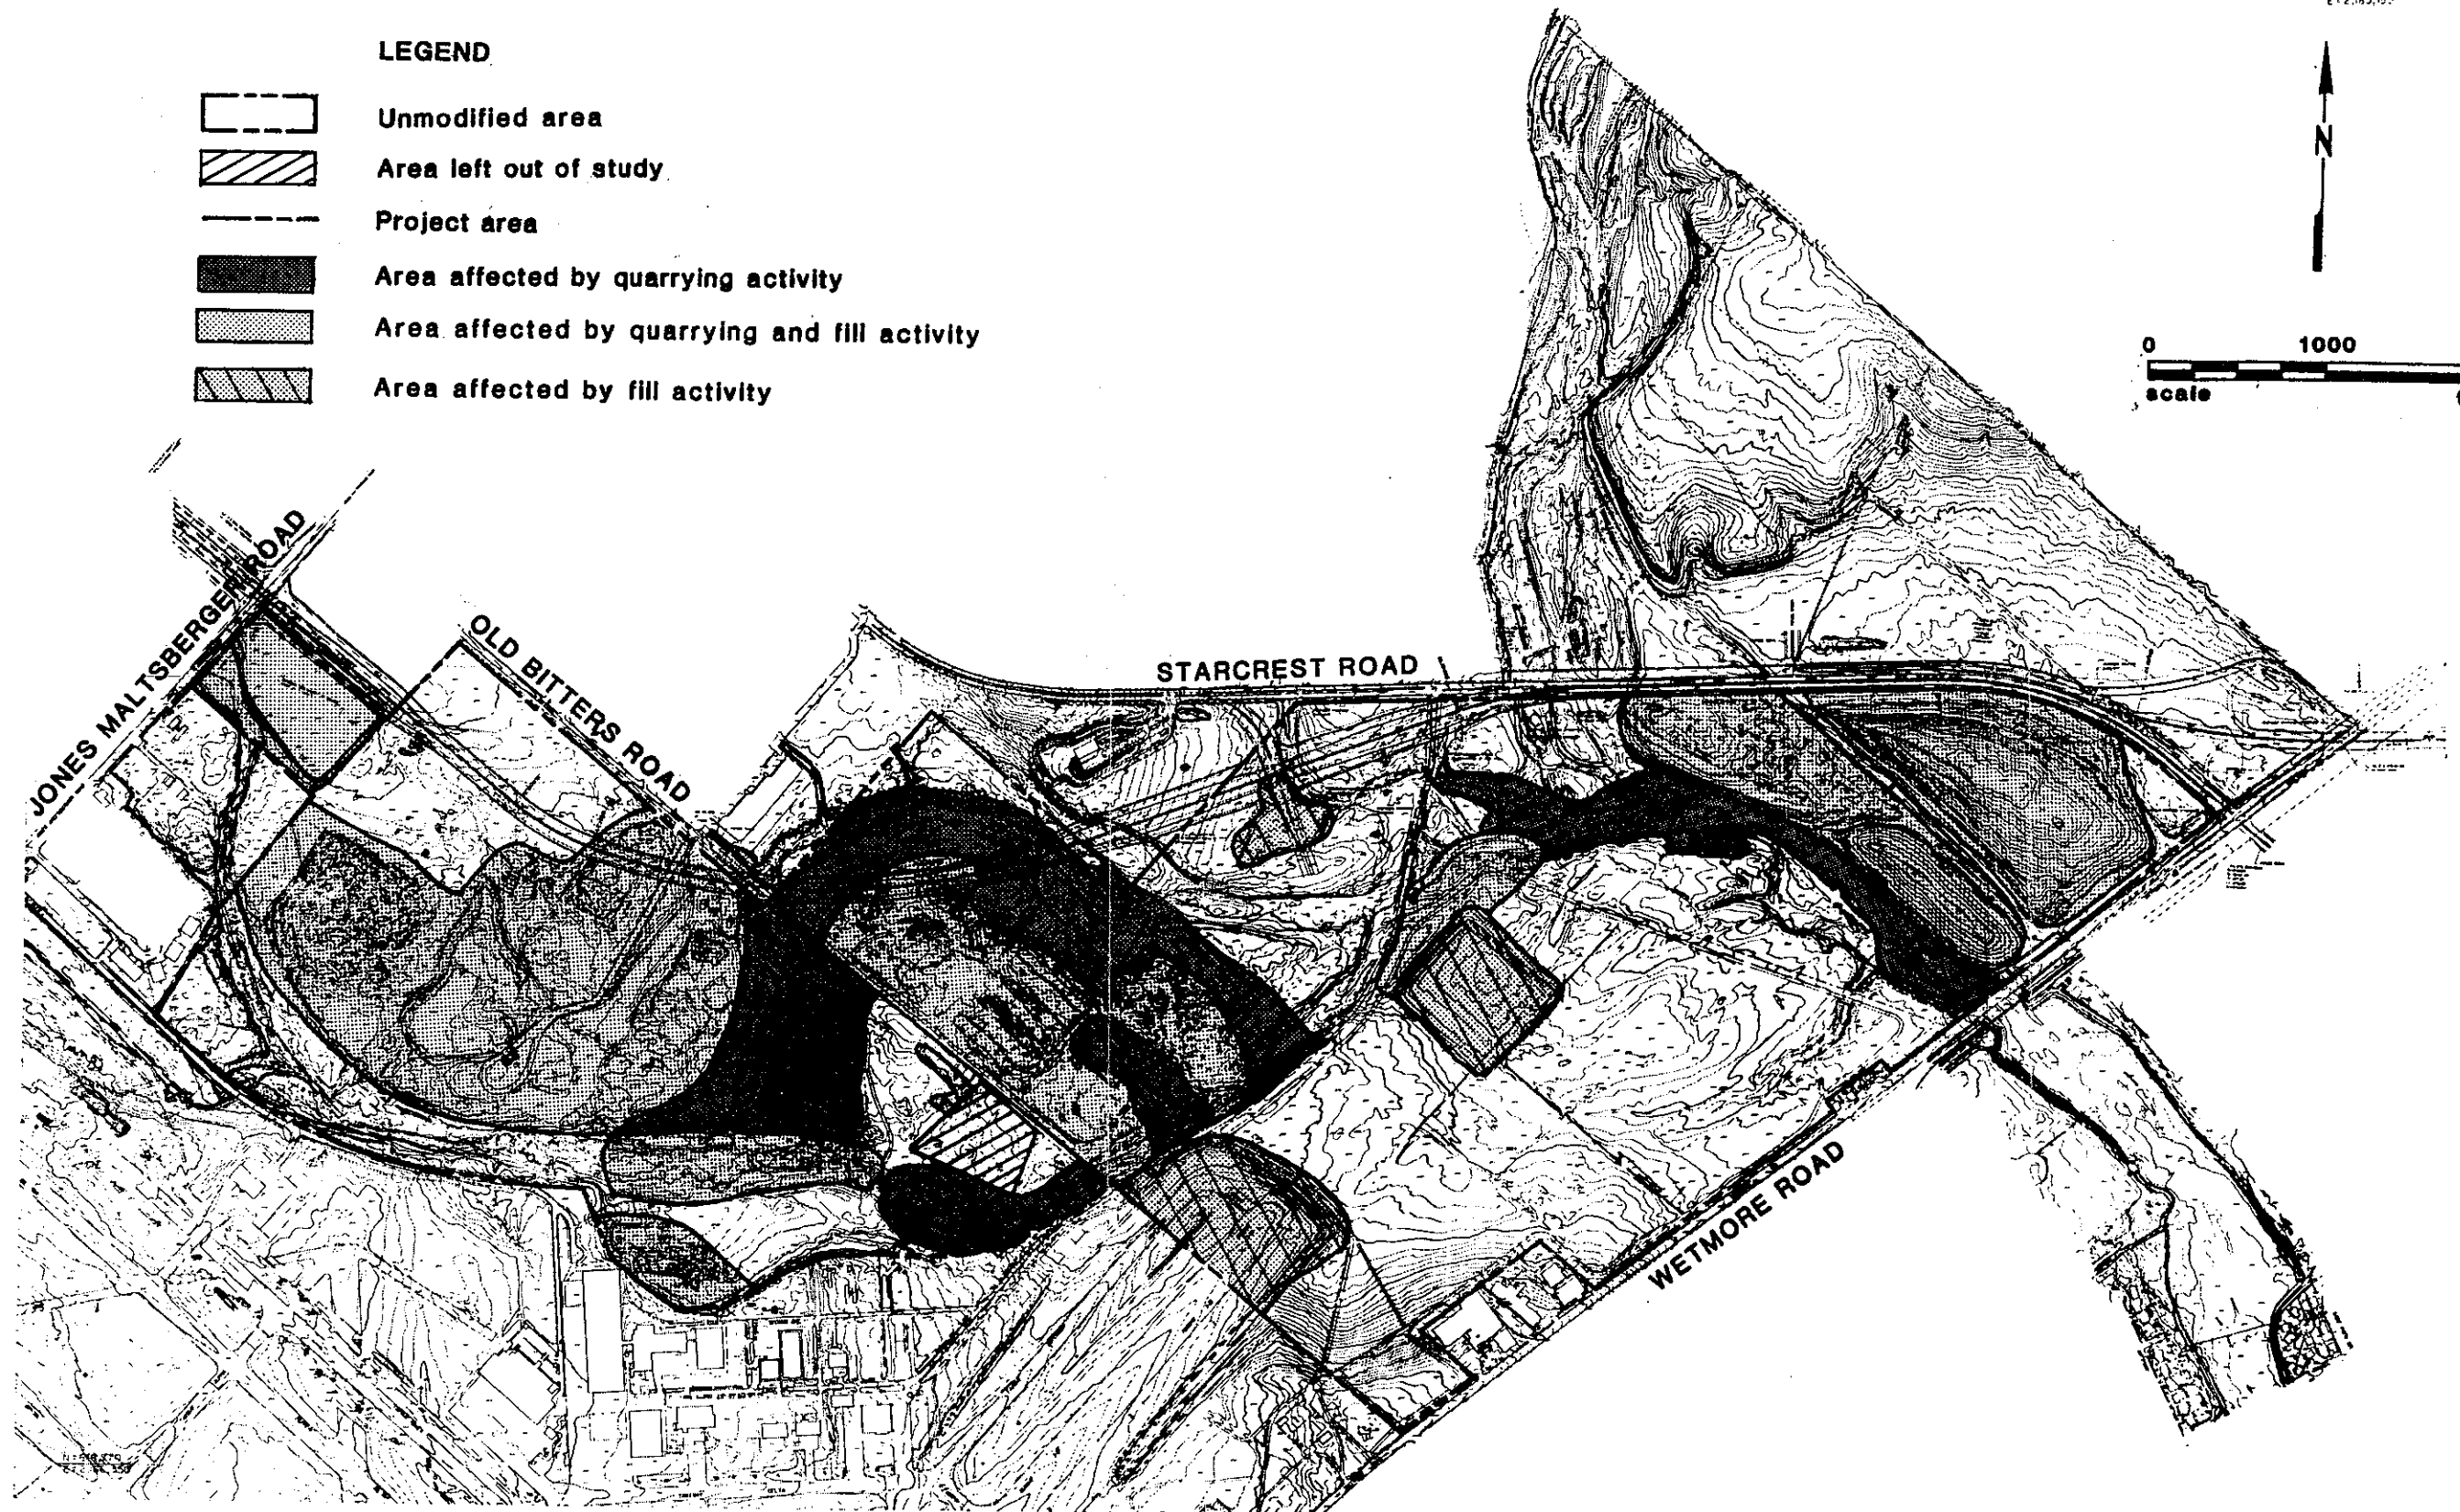
PRELIMINARY DELINEATION OF AFFECTED AREAS  
SAT LRMP - SAN ANTONIO, TEXAS

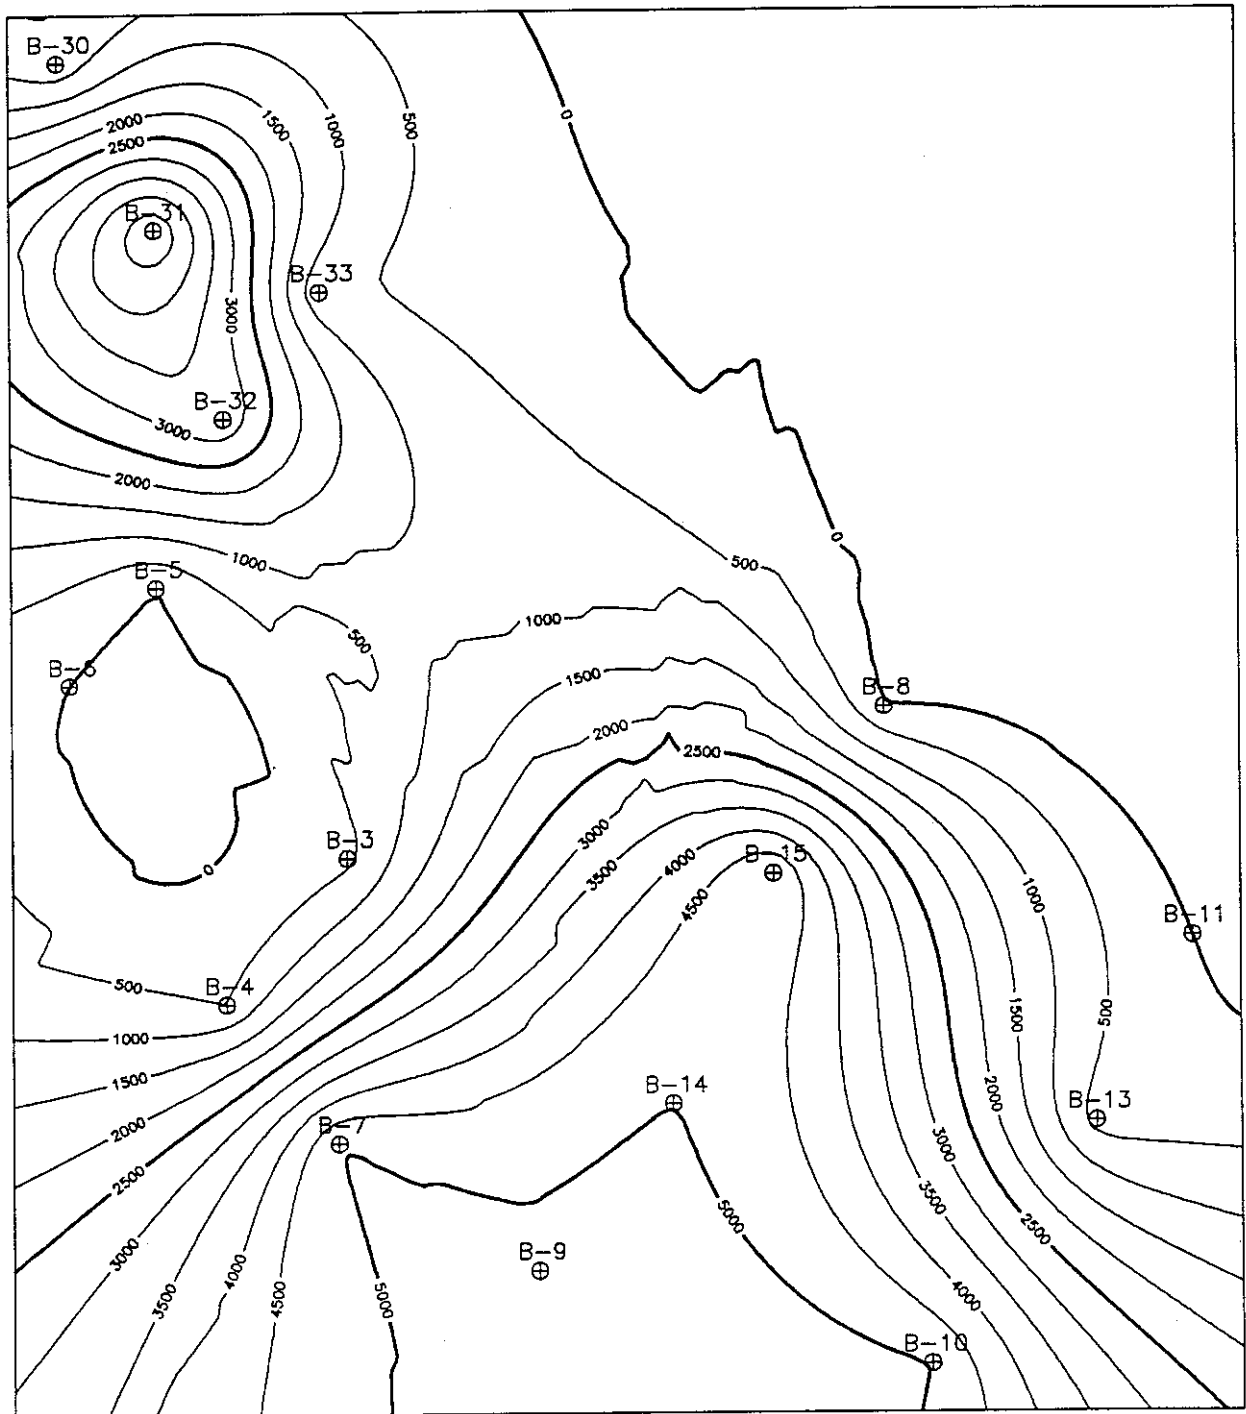
H-206 PLATE 11-

The maximum reading at each open boring was contoured and the resulting map of open boring combustible soil gas concentrations is presented on Plates 11A, 11B, and 11C. The location of Plates 11A, 11B and 11C relative to the property boundary is shown on Plate 12. Borings which had a reading of >5000 ppm were contoured as 5000 ppm.

# SAT LRMP OPEN BORING SOIL GAS ISOCONCENTRATION MAP

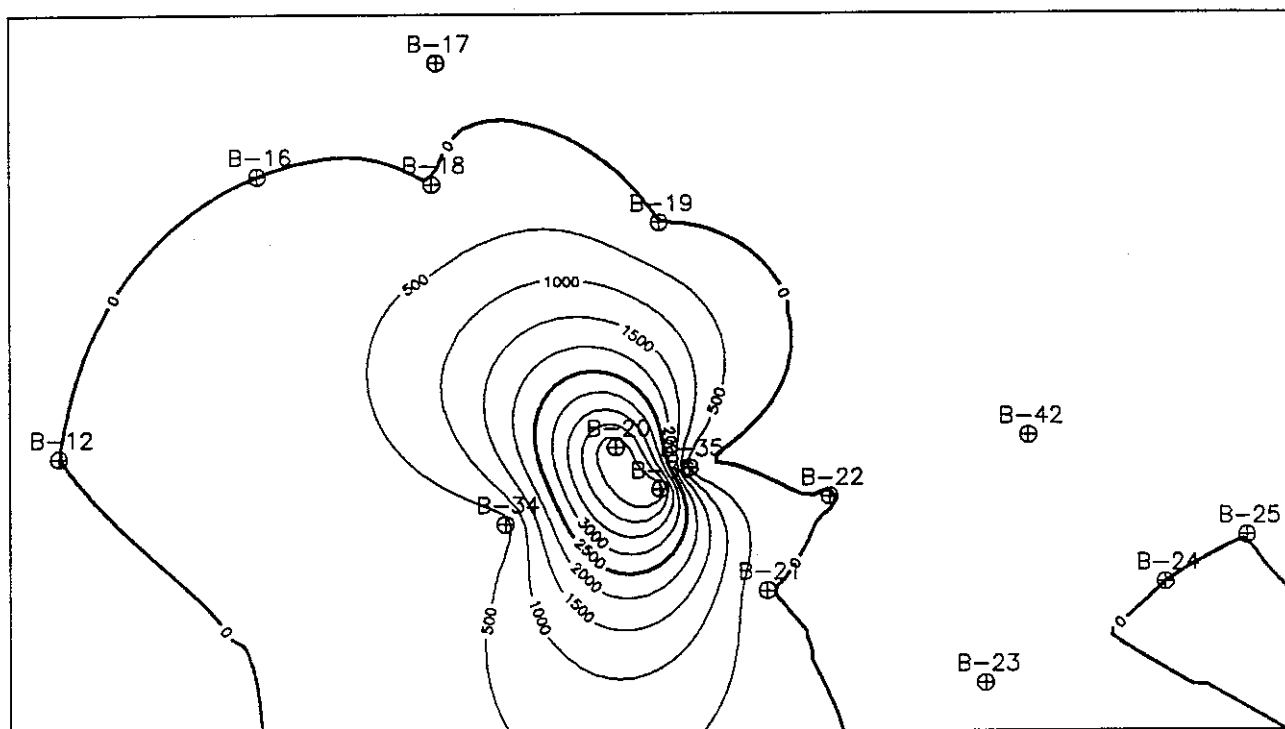
PLATE 11-B  
H-207

SAT LRMP OPEN BORING SOIL GAS ISOCONCENTRATION MAP

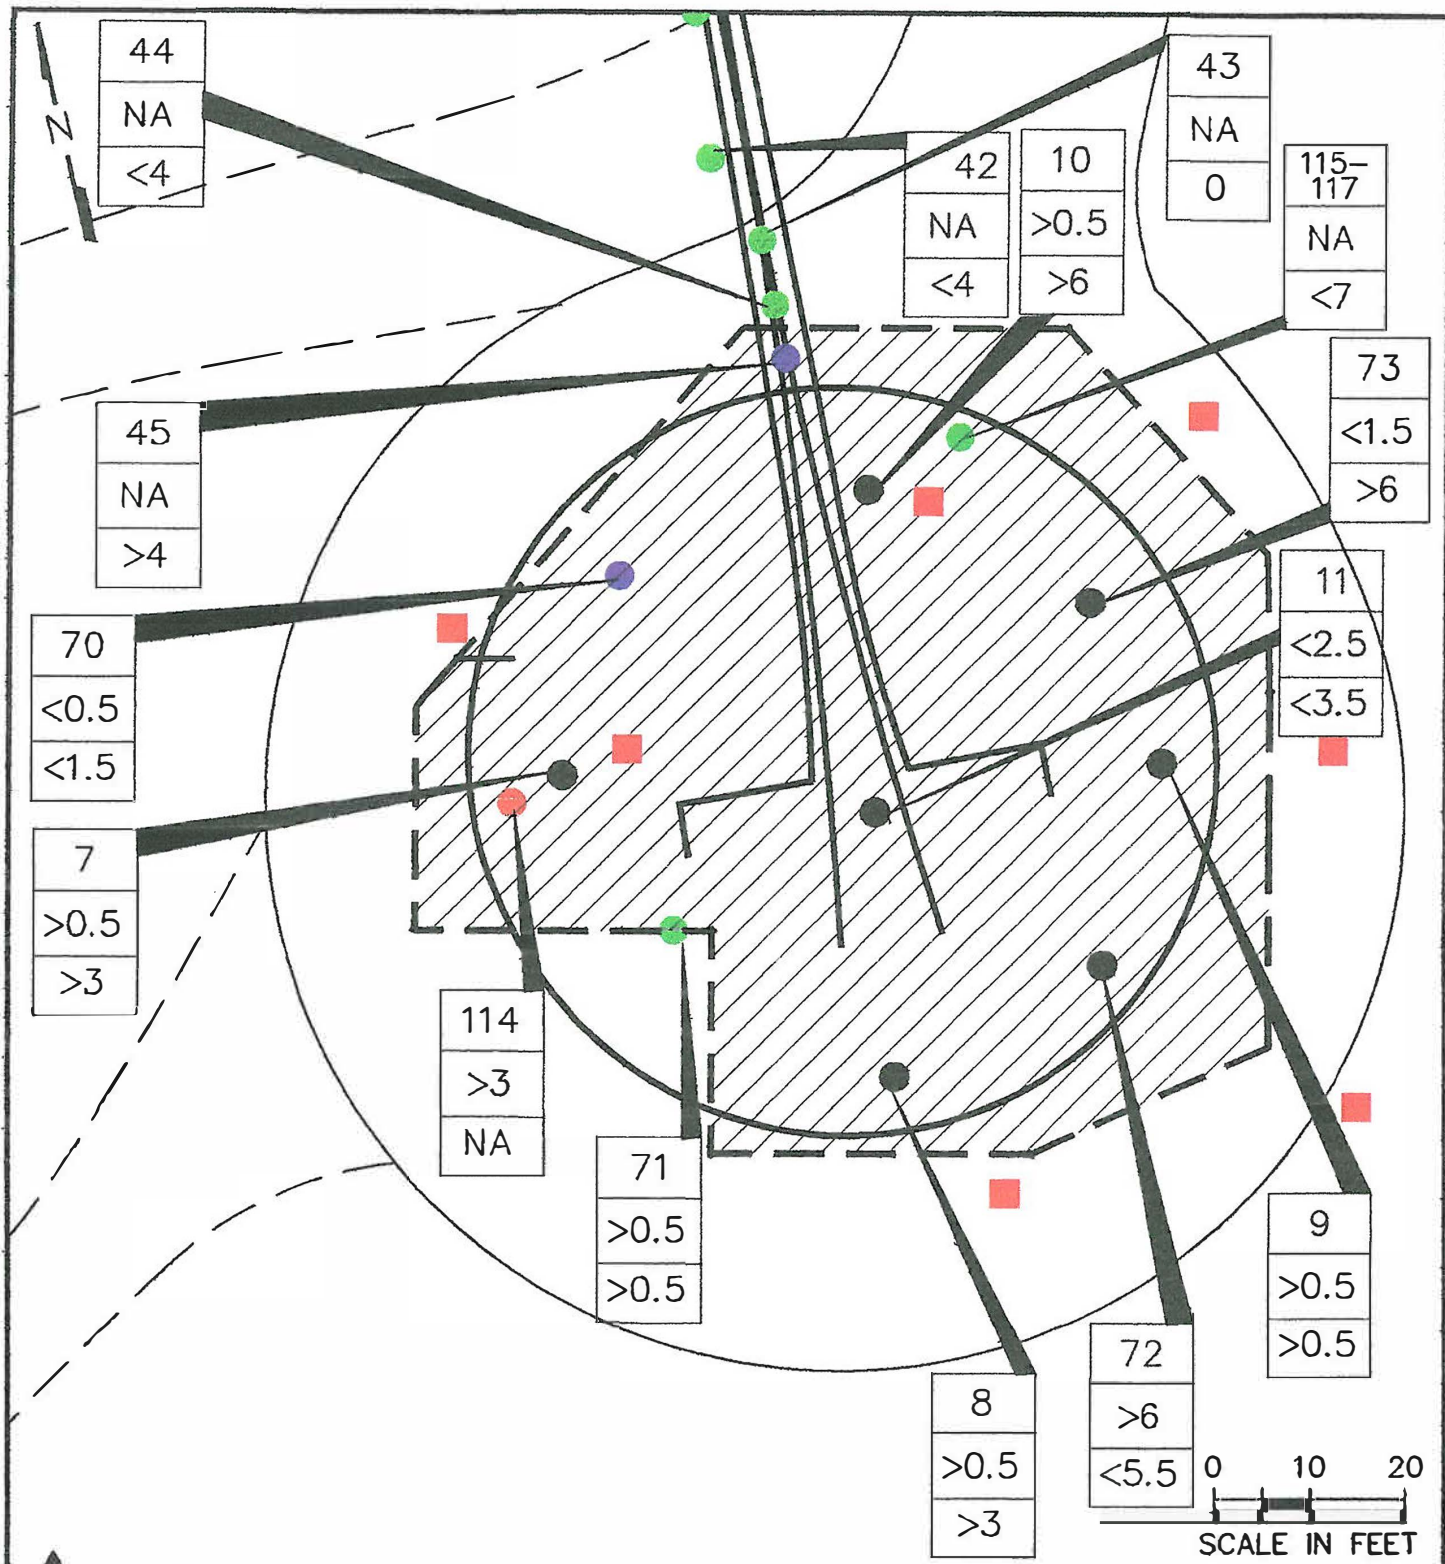
### FIGURE 5 PROPOSED ADDITIONAL BORINGS CURRENT BURN PIT FIRE TRAINING AREA

TPH, lead, arsenic, barium, and selenium were identified at the CBP. Other metals were analyzed for on a limited number of samples only. The extent of TPH contamination extends to various depths in the area and appears to be limited to the upper 8 feet of soil. Lead appears to be the indicator parameter for metals contamination. Lead was identified at a depth of 6 feet. No samples collected below 6 feet were analyzed for metals. The extent of contamination is not well defined vertically or along the east, south, and west ends of the AEC. Previous soil sampling locations and the proposed additional soil boring locations in the vicinity of the CBP are presented on Figure 5.
